Minerals Inspection Report

| Mine Name: Nielson Sandstone | Permit Number: | M/023/0012 | Mine Status: | Active |
| Operator Name: Ash Grove Cement Company | Inspection Date: | 04/07/2015 | Permit Fees: | Paid |

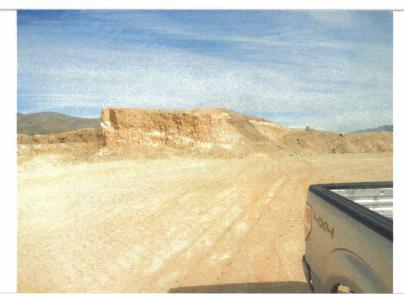
Active pit area note highwalls in the distance.

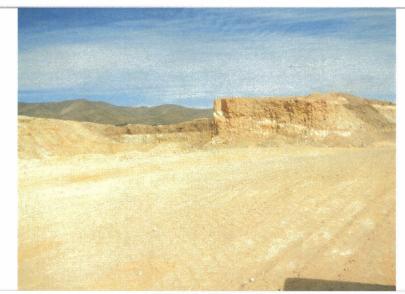
Active area pit has a flat bottom and no signs of erosion

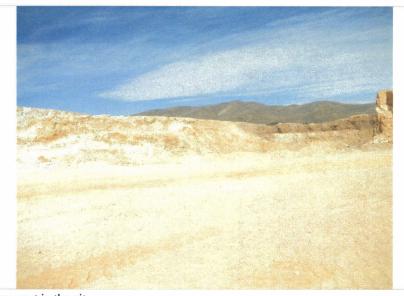
Looking west in the pit.

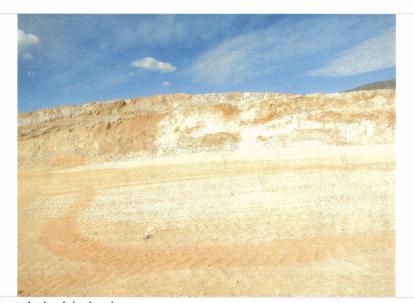
Looking at bedrock in the pit.
